IMCA Safety Flashes summarise key safety matters and incidents, allowing lessons to be more easily learnt for the benefit of all. The effectiveness of the IMCA Safety Flash system depends on members sharing information and so avoiding repeat incidents. Please consider adding [safetyreports@imca-int.com](mailto:safetyreports@imca-int.com) to your internal distribution list for safety alerts or manually submitting information on incidents you consider may be relevant. All information is anonymised or sanitised, as appropriate.

## 1 Unexpected Descent and Ascent of Mattress Lifting Frame

## 2 High potential: dropped chain assembly

### 3 Electrocution incident – make sure electrical equipment is safe!

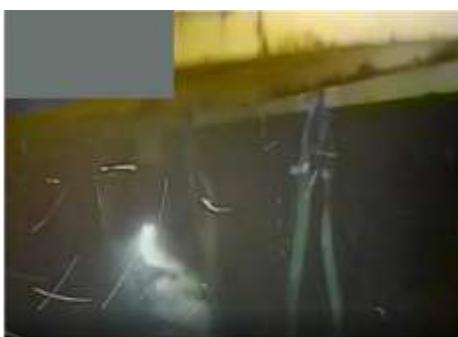
Position 2 – Frame during ascent

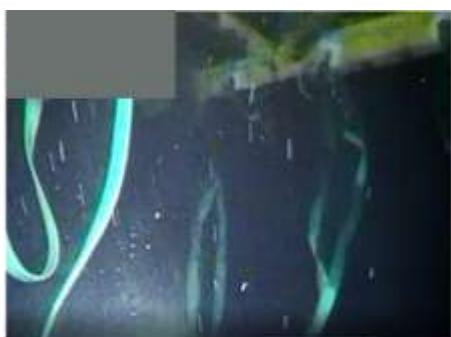
Position 3 – Frame at end position

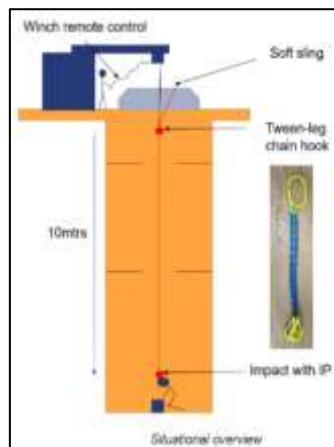
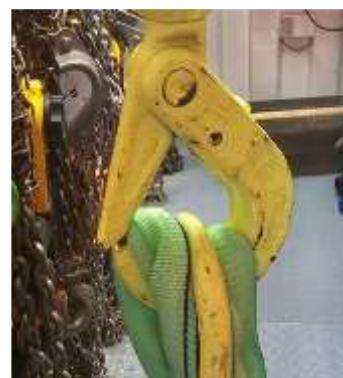
- The lifting technique was not correct: The fibre of the soft sling was caught in between the hook and latch preventing the safety mechanism from locking;
- People were in unsafe positions:
  - The person with the remote control on the external platform did not have view of the load he was lowering;

*Sling preventing proper closing of the hook*

- Always check the lifting accessories are placed correctly in the hook;
- Ensure there are no people under the load – including the rigging itself which is also to be considered a load;
- Always keep an eye on the lift.
- Communicate lifts and inform team members on restricted areas;
- Does the crew have sufficient experience to perform the given tasks safely?
- Supervise less experienced colleagues;
- Follow the Life Saving Rules; wear PPE.

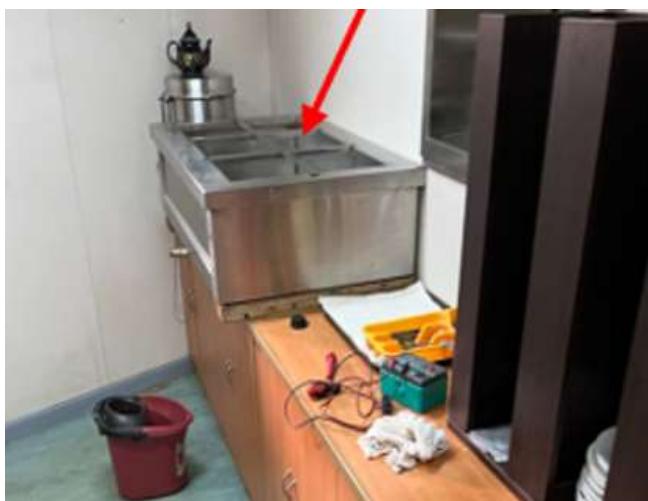
*Bain-marie in galley*

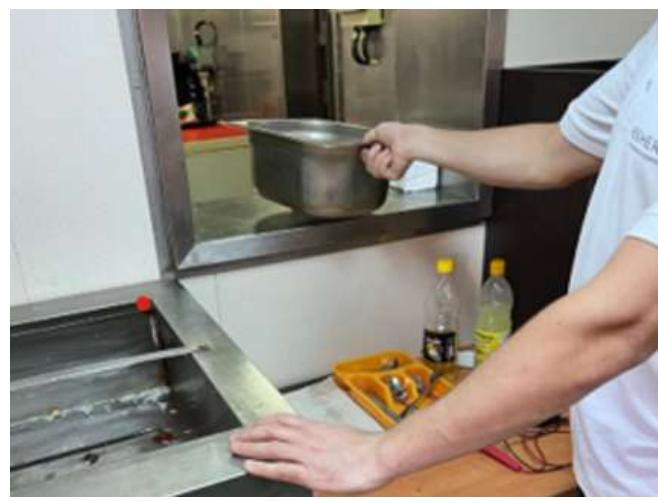
A vessel cook received a mains electric shock when he simultaneously touched a metal bain-marie (the metal electrically heated serving containers commonly used in messrooms) **AND** the messroom service window with both of his hands.

*Position of cook's hands when shock received*

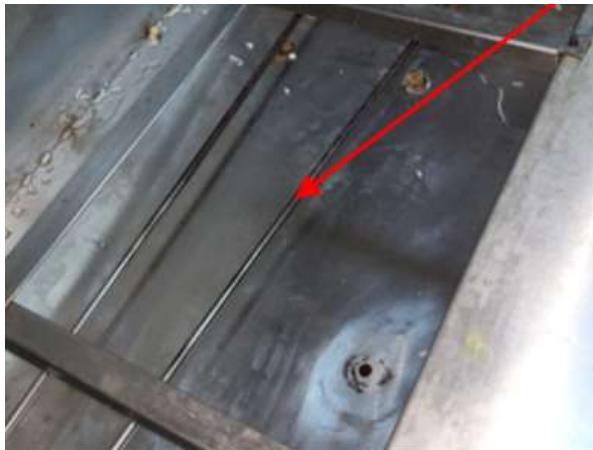
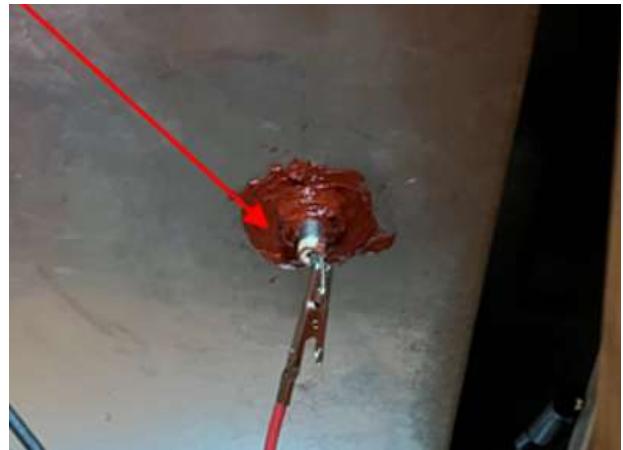
Showing earth fault of the electrical heating element

- There was an earth fault in the electric heater element of the bain-marie due to a detached earthing wire;
- There had been no recent testing or maintenance of the galley electrical system;

- Thorough inspection for and removal of, any damaged or deteriorated electrical equipment;
- Arranged unscheduled test of all stationary and portable electrical equipment on board vessels fleetwide;
- Added galley electrical equipment inspection and maintenance to planned maintenance system;
- Updated Onboard Risk Assessment for use of portable and other electrical equipment on board to include equipment in the galley and the mess.

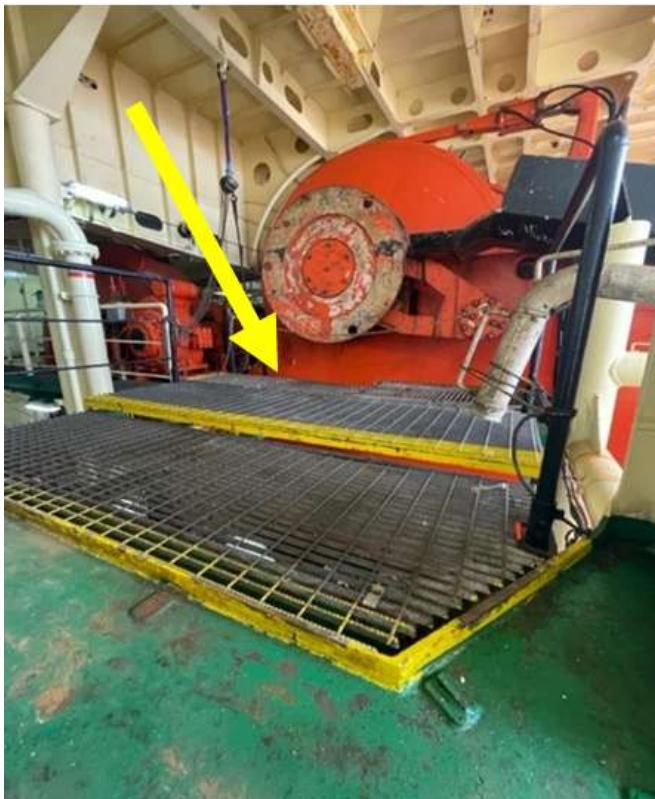
Inspection of A-deck found that the safety chain was not in place. Safety chain could not be confirmed to be in place as it was found in the down position with a link missing. A carabiner was still in place at one end and a welded link in place on the other. Missing link on welded end could not be located.

*'A' deck showing the area around the gypsy and grating walkway including different levels highlighted by yellow paint. The yellow arrow denotes the space in which the IP fell between winch gypsy and grating.*

- Improved barriers to be installed around port and starboard gypsies;
- Update Shipboard/Contractor Familiarisations and Inductions to include identification of restricted and working areas;
- Replace all chain barriers with gates or solid railings. All restricted/working areas to be identified and signage posted. Temporary chain barriers and signage were put in place as a short term measure until solid hand rails could be fabricated and fitted;
- Install barriers and signage to clearly identify working areas.

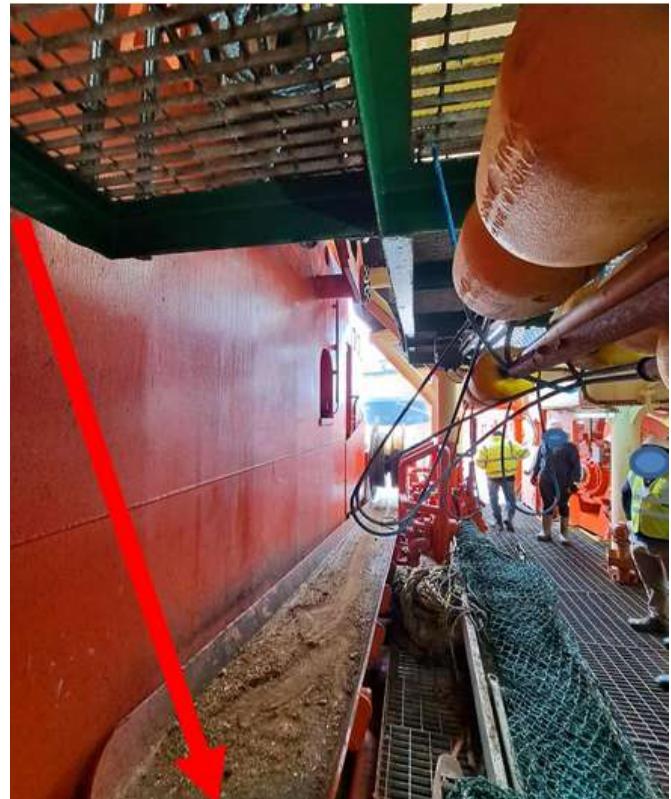
*Main deck showing chute where IP landed from the grating above (height of approximately 2m). Red arrow depicts the drop zone and area where IP landed.*
