IMCA Safety Flashes summarise key safety matters and incidents, allowing lessons to be more easily learnt for the benefit of all. The effectiveness of the IMCA Safety Flash system depends on members sharing information and so avoiding repeat incidents. Please consider adding [safetyreports@imca-int.com](mailto:safetyreports@imca-int.com) to your internal distribution list for safety alerts or manually submitting information on incidents you consider may be relevant. All information is anonymised or sanitised, as appropriate.

## 1 Fire in engine room

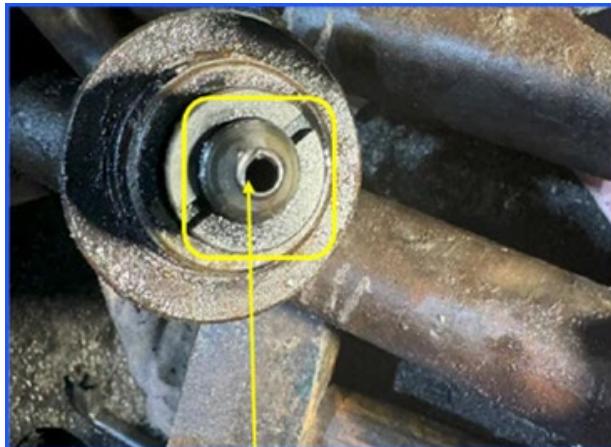
High Pressure Fuel Pipe Sealing Found With Scuffing marks

- The most likely cause as a fuel leak from a high-pressure pipe which had been misaligned during re-assembly;
- Blocked leak detection tubing failed to alert the crew to the fuel leak in a timely manner;
- Additionally, blocked drain lines from the hot box prevented proper fuel drainage, leading to fuel accumulation;
- The accumulated fuel ignited upon contact with the engine's hot surfaces.

- Proper Re-Assembly and Maintenance
  - Alignment of Components: Misalignment during re-assembly can lead to serious failures, such as fuel leaks. OEM manual procedures and checks must be followed to ensure that all components, especially high-pressure fuel systems, are correctly installed and secured.

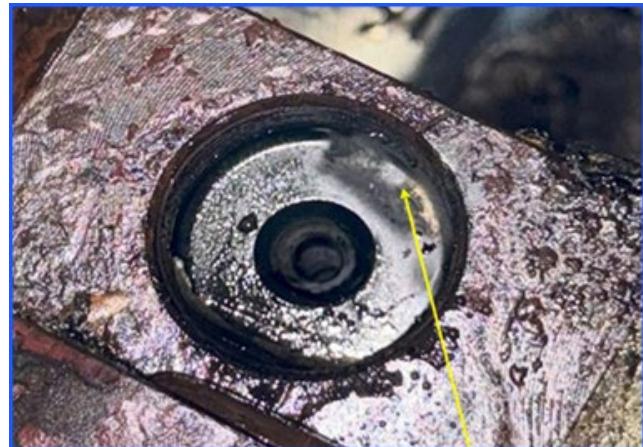
Pressure Fuel Pump Outlet Port Found With Sign Of Fuel Leakage

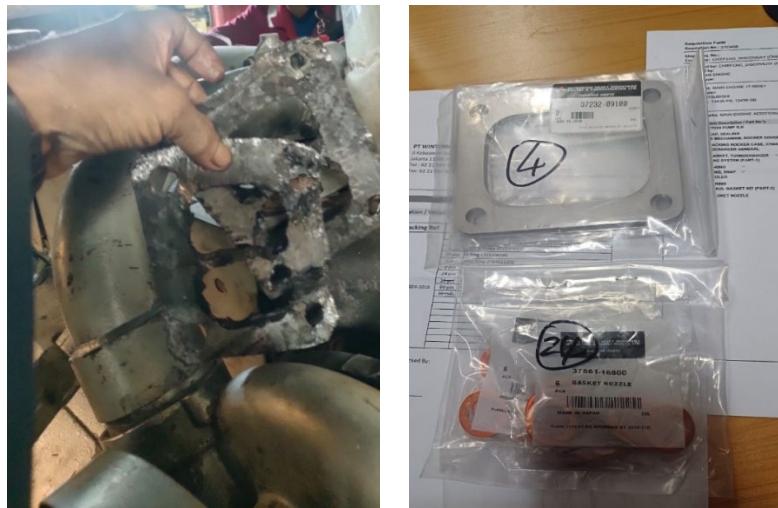
It was found that the gasket on the turbocharger flange was damaged.

An incorrect gasket was installed that did not meet the required specifications. The required gasket needed to have a temperature resistance above 500°C, whereas the installed gasket had a specification below 300°C.

- Check carefully that equipment and spares used, particularly in safety critical equipment, meet the specified requirements;
- There is a difference in appearance between gaskets designed for temperatures above 500°C and those designed for temperatures below 500°C. Those designed for temperatures above 500°C will feature a visible wire mesh in the middle of their structure.

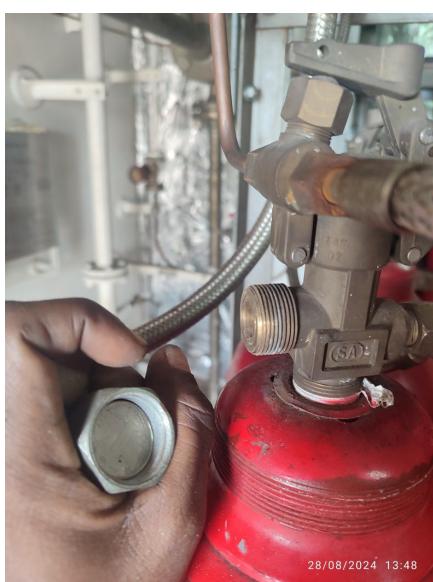
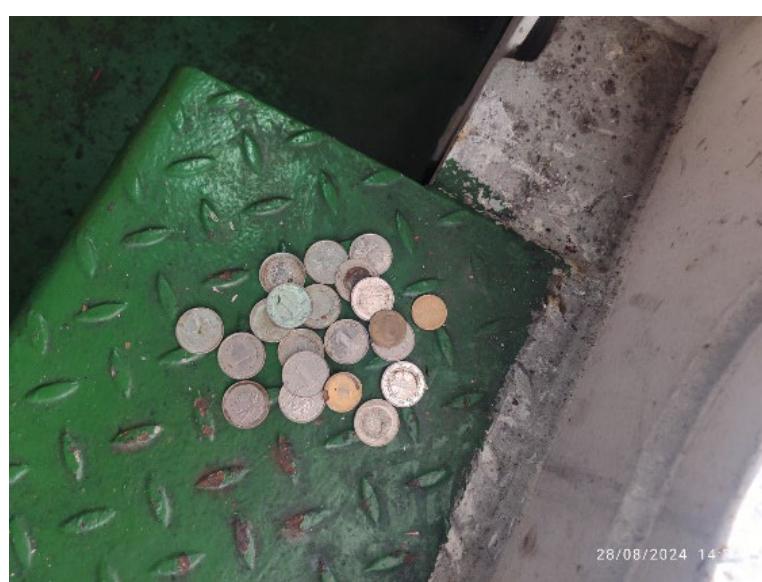
**Coins were found inserted into CO<sub>2</sub> fire fighting cylinders.** During a 10-year third party specialist inspection of a vessel CO<sub>2</sub> fire suppression system, coins of Chinese manufacture were found inserted in 21 out of 24 main 45 kg CO<sub>2</sub> cylinders. These coins were found blanketing high-pressure hoses, potentially compromising the effectiveness of the CO<sub>2</sub> fire suppression system. The presence of foreign objects in such critical safety systems poses a severe risk to crew and vessel safety.

- Conduct an immediate inspection of the hose connections of the vessel's CO<sub>2</sub> fire suppression system. Any anomalies or concerns discovered during inspections can then be rectified immediately.

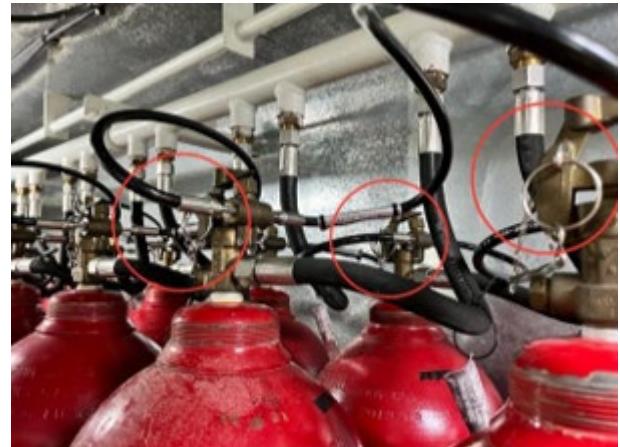
The incident occurred following a major refit / dry docking. The vessel departed port and sailed to its area of operation to complete the works and prepare for being commercially available. On arrival, the Flag State carried out an inspection of the vessel and found that all of the CO<sub>2</sub> bottles for the engine room fire suppression system still had their safety pins in place. This means that if there had been an engine room fire, the crew would have been unable to set off the suppression system remotely and any deployment of the system would have been seriously hampered and hindered.

The safety pins had been put in at the start of the dry dock, as was usual. At the end of the dry dock when the vessel was floated, the fire suppression system was tested by a third party. The safety pins were still in place and the third party left them in situ during testing. After the tests, the third party testing company stated that the system had been put back into service. However, the pins were not removed and were subsequently missed on any pre-sailing or coming out of dry dock checks.

- Appropriate personnel should be fully familiar with the procedures for operating vessel CO<sub>2</sub> fire suppression systems;
- Work on safety critical equipment, including that done by a third party, should be covered under a Permit to Work and should be verified by a deck officer;
- Carry out a check to ensure that safety pins are removed from CO<sub>2</sub> fire suppression systems and indeed any other safety critical equipment after dry docking – ensure such equipment is ready for immediate use.

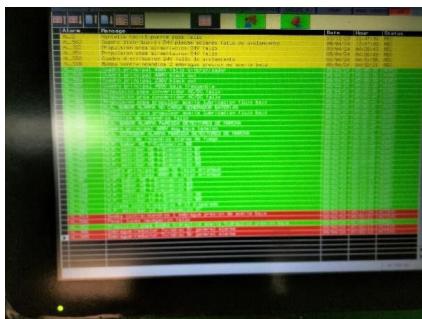
Alarm notification screen

- It was discovered that the firefighting system was activated by a sudden rise in battery voltage following the malfunction of the solenoid valve on the pilot cylinder, after the blackout;

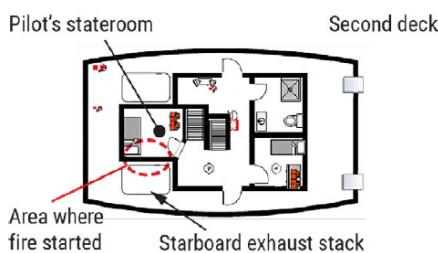
*Layout of part of the vessel. The dashed oval identifies where fire started.*

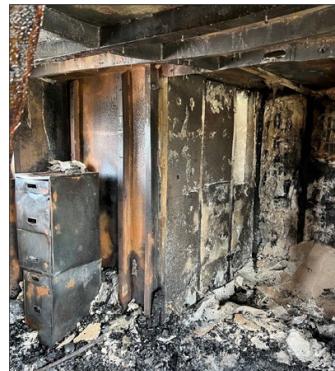
*Burnt out stateroom*

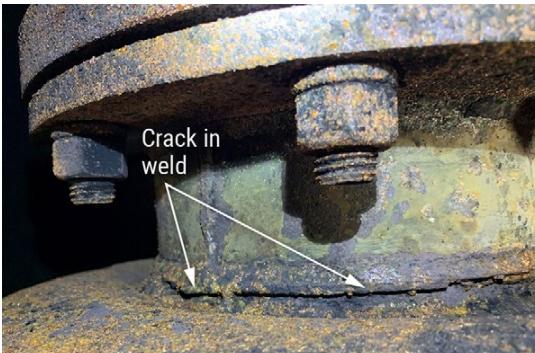
A fire had started behind panels in the pilot's stateroom, which was located between the vessel's two stacks, each containing engine exhaust mufflers and piping. Cracks in the welds on the upper section of the starboard muffler located inside the starboard stack—which may have been caused by a latent issue, such as a defect in the muffler during construction or the exhaust system design's allowance for thermal expansion and contraction of exhaust piping above the muffler outlet—allowed the hot exhaust gases from the operating starboard engine to escape into the stack area and increase the temperature of the space and its bulkheads.

The NTSB's investigation suggested that **undetected cracks** in the starboard muffler allowed exhaust gases from an operating engine to escape and ignite wooden structures affixed to the common bulkhead of an accommodation space. Contributing to the extent of the fire damage was the substantial use of combustible materials in the joinery, outfitting, and furnishings in the accommodation spaces.

*Crack in weld below the upper (outlet) flange of the starboard muffler*

- Remember that engine and other machinery exhaust systems generate tremendous amounts of heat. These systems often run through tight spaces that are difficult to access and inspect and are often located near materials or equipment that obstruct entry and direct observation;
- Consider inspection of welding and other potential weak points in such areas.
