IMCA Safety Flashes summarise key safety matters and incidents, allowing lessons to be more easily learnt for the benefit of all. The effectiveness of the IMCA Safety Flash system depends on members sharing information and so avoiding repeat incidents. Please consider adding [safetyreports@imca-int.com](mailto:safetyreports@imca-int.com) to your internal distribution list for safety alerts or manually submitting information on incidents you consider may be relevant. All information is anonymised or sanitised, as appropriate.

## 1 Diver exposed to unplanned release of production gas

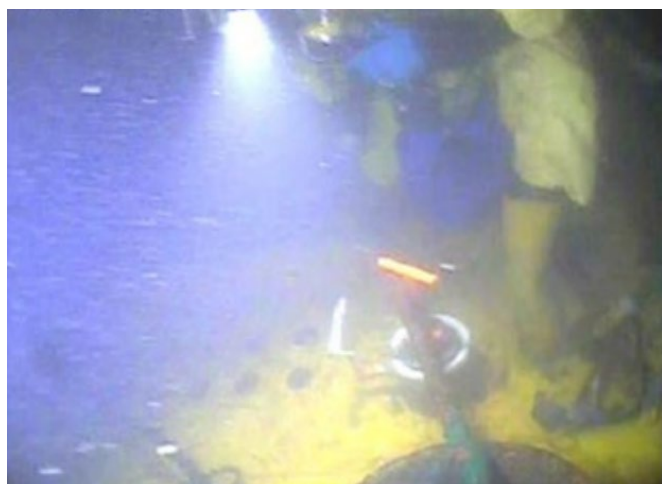
During saturation diving activities at 65m water depth, from a Diving Support Vessel (DSV), a diver was exposed to a sudden and unplanned release of hydrocarbon gas under pressure (estimated pressure >150bar). The pressure release resulted in ejection of a stuck blind stab and the diver being pushed backwards by the force of the gas. The diver was unharmed. Our member considered the incident to be a very high potential near miss.

Nearing the end of the bell run, saturation divers were working on a subsea skid when they identified incorrect tagging. Work was stopped and the divers were then instructed by the Diving Supervisor to proceed with a dummy stab removal at the same location, using hand tools (T-Bar and hammer). During initial hammering of the dummy stab, a discharge of gas bubbles was observed coming from the receptacle, followed by a larger one. At this time, both divers were instructed to stop working for ten minutes to allow for the gas to discharge. Diver 1 was instructed to return to the bell and Diver 2 was subsequently instructed to restart tapping the blind stab with the hammer. Suddenly the dummy stab ejected and trapped production gas was released. Diver 2 was positioned just outside the line of fire, but he was pushed backwards by the force of the gas release, though he remained on the top of the skid.

*Stuck blind stab*

- The incident has similarities to a previous incident that occurred during diving operations in the North Sea (see reference below). It is important to verify that lessons are learned from previous incidents and that preventative and critical controls from high potential incidents need are in place;

- Remind each other that we have procedures and processes which are there to help us.
- Review procedures and task plans to ensure that there are critical “hold points” included detailing the use of the ROV tools.

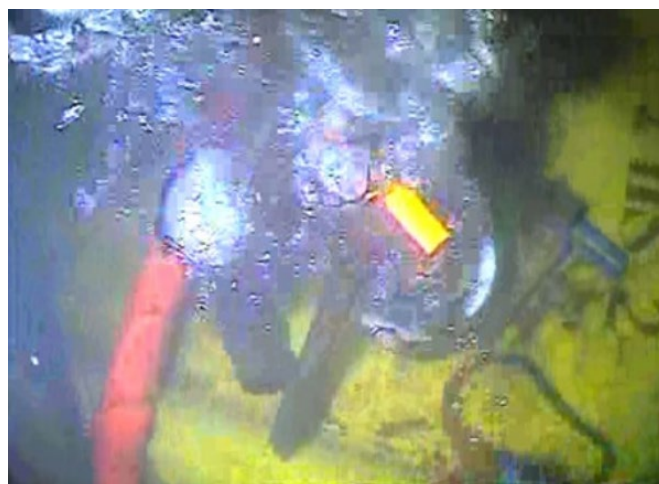
*Production gas bubbles coming out of the receptacle*

- The divers continued with dummy stab removal despite the gas bubble release without challenging the ‘as-found’ condition.

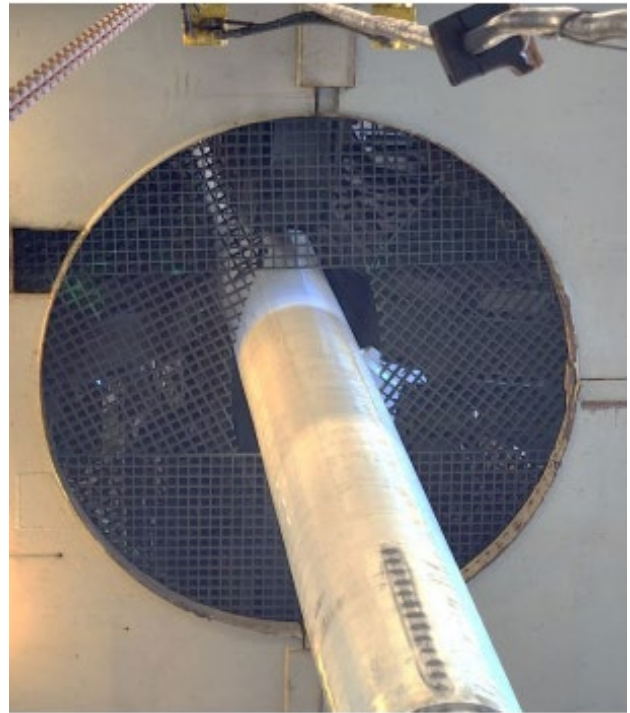
*Gap in the mesh platform that the block fell through*

- The dropped object (wooden packing block), used for crossover packing on the spooler reel, had compressed into the parent coating of the pipe. It was thought that this was the mechanism that has transported the block on the pipe and into the lay system;
- The DROPS barriers on the workstation were inadequate to prevent a wooden block getting through the gap around the annulus of the pipe. The drops barrier is also susceptible to movement from pipe deflection without retracting with the pipe, and this could potentially widen the gap around the pipe. The dropped object passed through this gap and landed on the workstation floor. Had the barrier been suitable to restrict the size of the smallest packing block the incident would have been prevented.

- Ensure all barriers are sufficient for the activities you are conducting;
- Ensure specific barriers (as in this case, around the pipe) are designed to minimise any gap to prevent the passing of potential dropped objects, whilst still allowing operations to proceed in a timely way;
- Ensure, so far as is possible, that there are no personnel in high risk/drops work areas;
- Be aware of risk normalisation and becoming accustomed to seeing unnecessarily dangerous situations in your workplace. Tolerating small defects or gaps in risk control can lead to major incidents;
- Consider new technologies available such as artificial intelligence using CCTV and alarms.

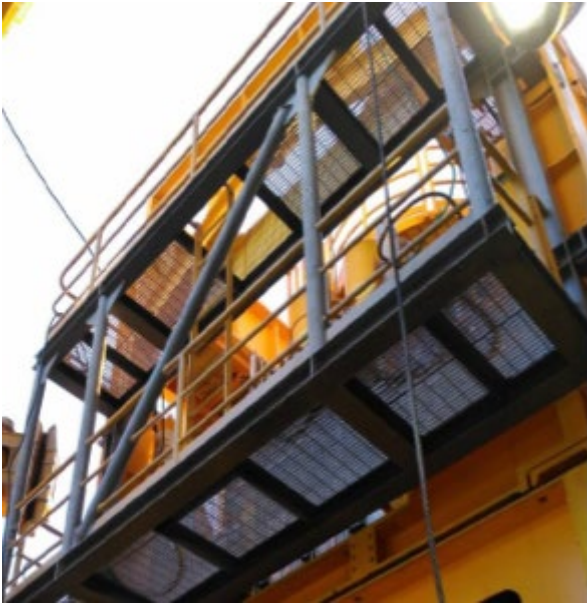
A worker on a blowout preventer platform fell through an open hatch cover that had been removed due to damage. The worker sustained injuries to his leg and knee.

*Area from which worker fell*

Multiple factors contributed to the incident, including a lack of situational awareness for potential hazards, inadequate fall protection measures, and the failure to 1) properly secure the hatch covering the hole, 2) take corrective action after the cover was removed, and 3) alert other personnel to the hazard.

- Check your surroundings prior to starting work for any potential hazards;
- Identify and document hazards and then communicate these to all personnel;
- Ensure the proper fall protection is used when working at heights;
- Check temporary equipment and work platforms for hazards prior to use;
- Use a spotter to help identify and communicate any hazards when working at heights;
- Install barricades and “flag up” areas with questionable walking or working surfaces. Soft barricades (e.g., caution tape) may be temporarily used, but hard barricades should be installed;

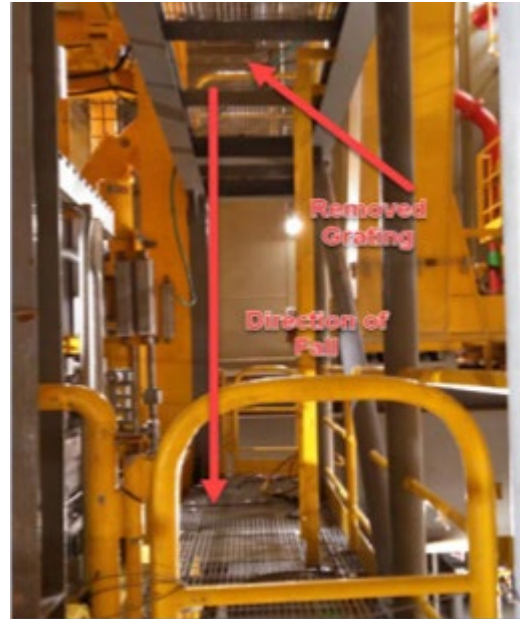
*Hatch cover removed*

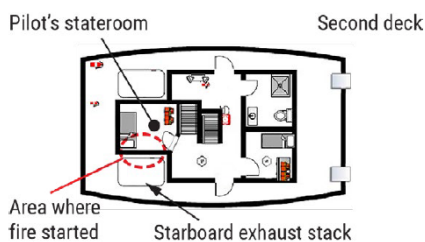
A fire had started behind panels in the pilot’s stateroom, which was located between the vessel’s two stacks, each containing engine exhaust mufflers and piping. Cracks in the welds on the upper section of the starboard muffler located inside the starboard stack—which may have been caused by a latent issue, such as a defect in the muffler during construction or the exhaust system design’s allowance for thermal expansion and contraction of exhaust piping above the muffler outlet—allowed the hot exhaust gases from the operating starboard engine to escape into the stack area and increase the temperature of the space and its bulkheads.

*Layout of part of the vessel. The dashed oval identifies where fire started.*

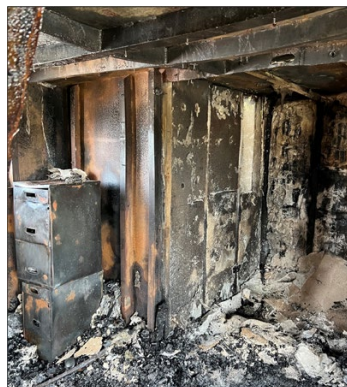
*Destroyed interior of vessel*

The NTSB’s investigation suggested that **undetected cracks** in the starboard muffler allowed exhaust gases from an operating engine to escape and ignite wooden structures affixed to the common bulkhead of an accommodation space. Contributing to the extent of the fire damage was the substantial use of combustible materials in the joinery, outfitting, and furnishings in the accommodation spaces.

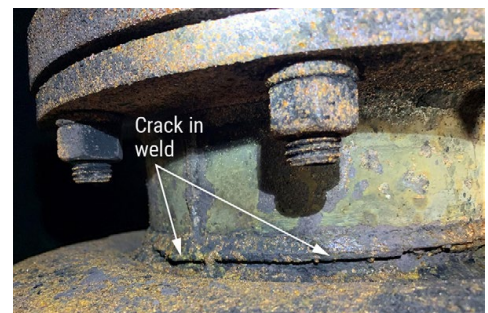
*Crack in weld below the upper (outlet) flange of the starboard muffler*

- Remember that engine and other machinery exhaust systems generate tremendous amounts of heat. These systems often run through tight spaces that are difficult to access and inspect and are often located near materials or equipment that obstruct entry and direct observation;
- Consider inspection of welding and other potential weak points in such areas.

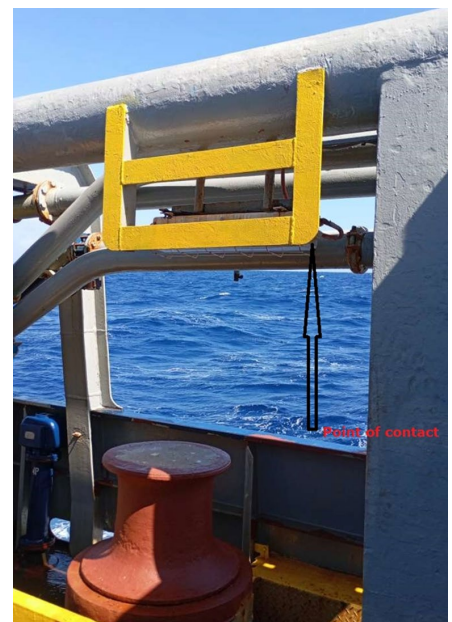
- The crane operator did not notice the potential snagging point, so continued the operation;
- The deck crew did not recognize hazard and did not stop the activity;
- Owing to the colour it was painted, the deck light guard may have been difficult for the crane operator to see and identify as a potential snagging point.

*Deck light guard*

The importance of the crane operator being able to see the job, and to have good communications with the deck crew, cannot be overstated.

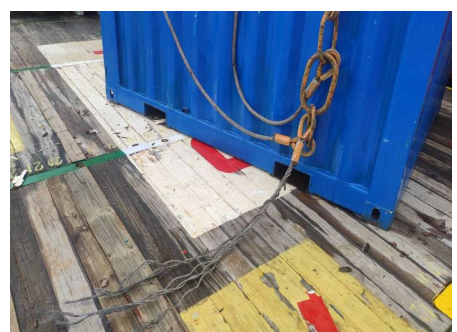
On a vessel engaged in deck cargo operations offshore, a number of lifts had been successfully discharged and backloaded, which led to limited space on deck. The crane operator had landed a 3m cargo container on deck, and while he was trying to re-position the lift for easy disconnection by the deck crew, the corner of the container became snagged on the side of a deck light guard resulting in the parting of one of the slings. The container with broken slings was safely stowed on deck. There were no injuries, no damage and no environmental impact.

*Damaged sling*
